Urban Search and Rescue in the Crested Butte, Colorado, State Bank Following an Explosion/Collapse

**Federal Emergency Management Agency
United States Fire Administration**
Office of Firefighter Health and Safety

**Urban Search and Rescue in
the Crested Butte, Colorado, State Bank
Following an Explosion/Collapse
March 6, 1990**

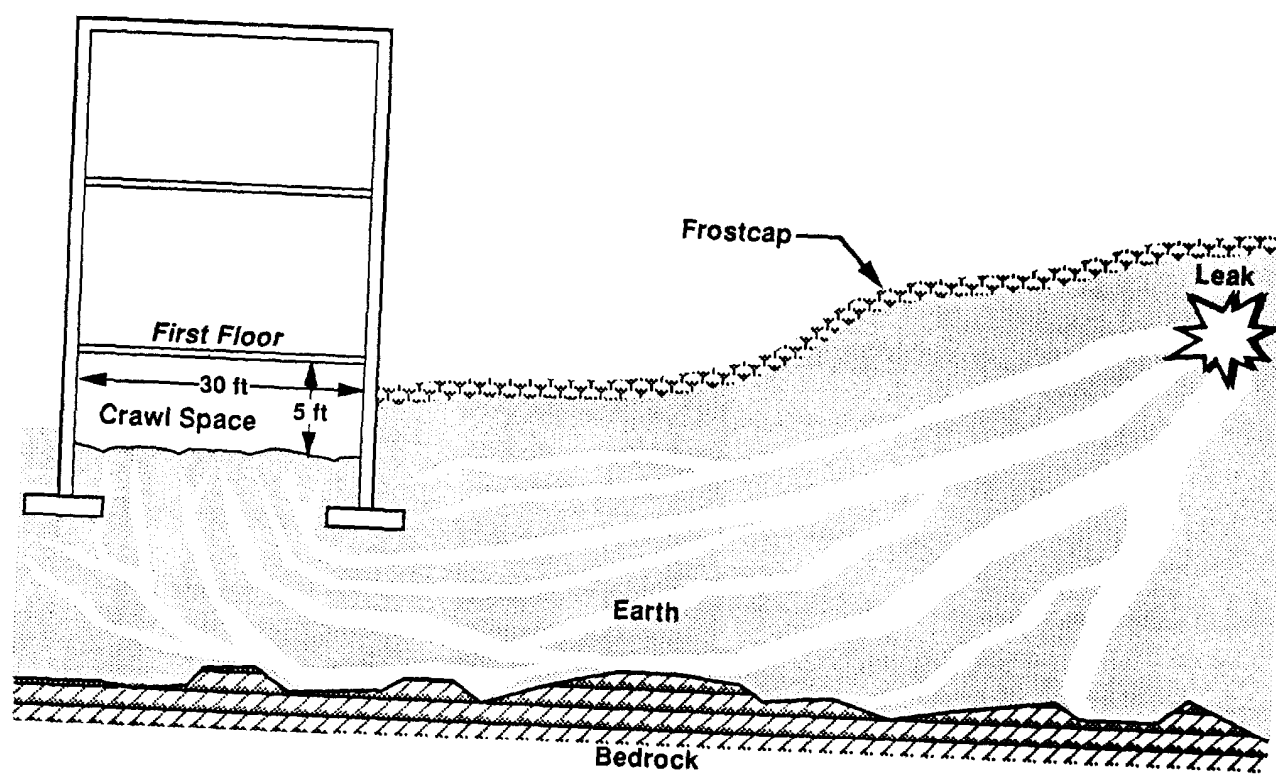
Spread from Propane Leak to Bank Building

Digging, pressurizing, and testing service pipes soon located a propane leak about 120 feet from the bank. The broken 1 1/2 inch propane pipe was the site of a previous leak which had been repaired three years before. The repair separated, and the leaking propane gas was scrubbed of its odorant, mercaptan, as it filtered through the earth. Heavier than air, the leaking odorless gas traveled much like water, away and down, seeking to equalize its level. Trapped between the bedrock below and a frost cap above, it crept along until it reached the earthen floor of the bank's 5-foot crawlspace. There it found its path of least resistance and entered the bank from below. An unknown source of ignition set off the gas.

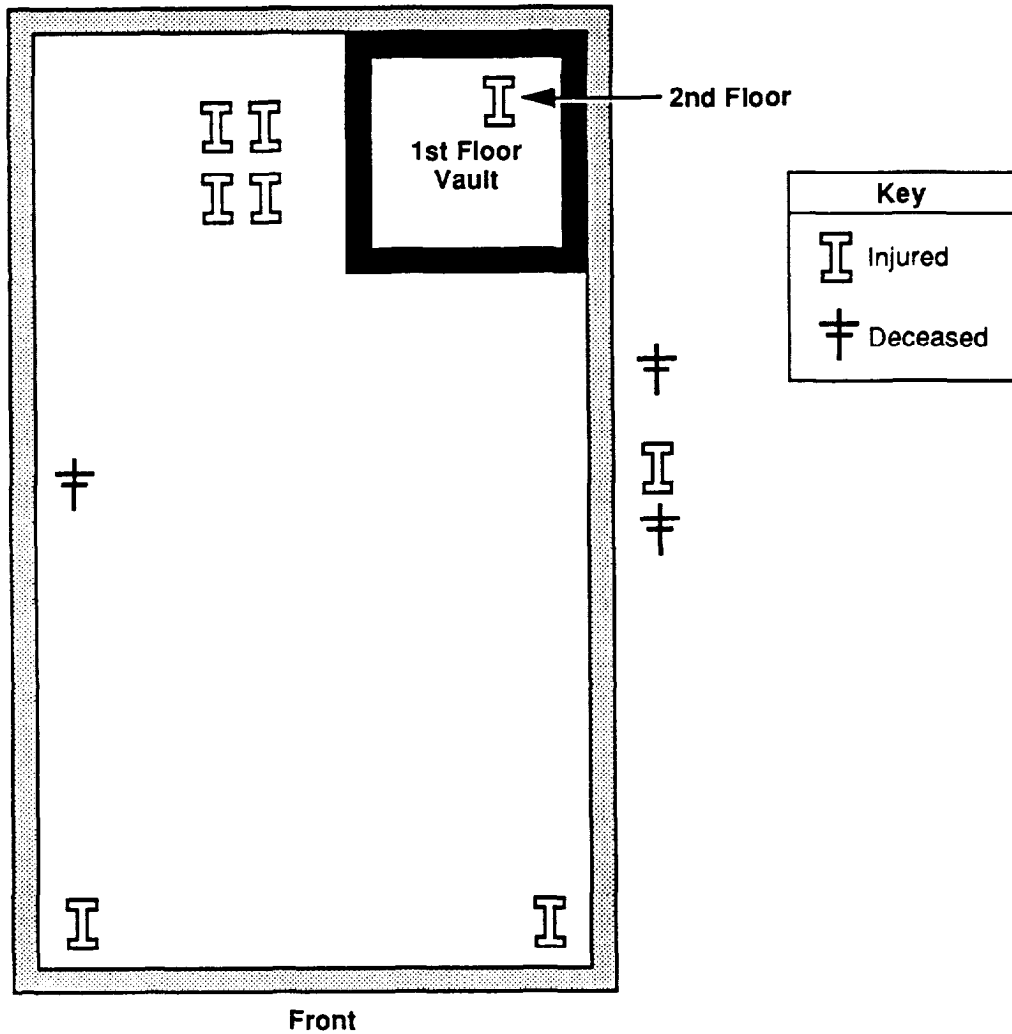
Crested Butte State Bank Explosion/Collapse Victim Location

Seven victims were removed from the structure alive: one from the second floor rear window, four trapped under a lean-to collapse in the rear of the building next to the vault, and two, who had been protected by office cabinets, from the front of the building. One victim was removed alive from rubble outside the building. Two of the deceased were found in rubble outside the building and one inside. The three people who died were women, ages 29,30, and 32. The remaining six victims were either blown clear of the building, dug out of the rubble early in the rescue operation, or were injured from flying debris while outside the building. There were 14 civilian casualties, who suffered first, second, and third degree burns, lacerations’ and trauma fractures.
